NRL/MR/6110--02-8632

# Green Thread Pipe Evaluation at Lualualei, HI and Jim Creek, WA

August 16, 2002

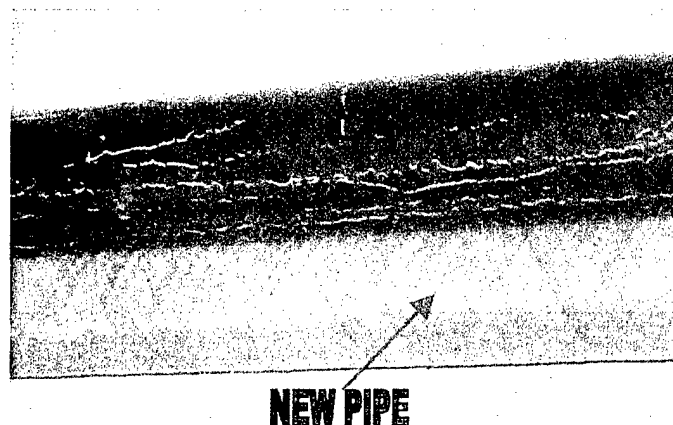
A darkening or a dark coating/deposit on the interior of the fiberglass tubing at the Lualualei site was observed in November 1997. The fiberglass pipe has a somewhat translucent light yellow/green color (bottom pipe) when new as seen in figure 1.

Figure 1. Examples of Green Thread pipe stored in warehouse at Jim Creek site, both new and a piece that had been in service.

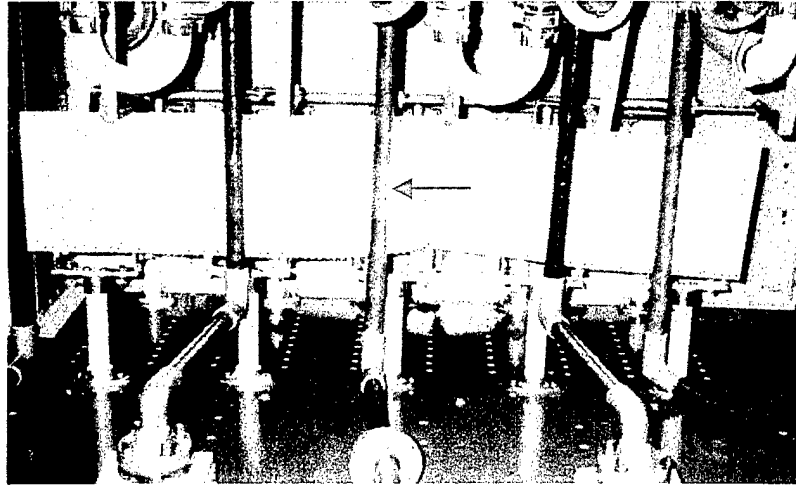
Figure 2. 1998 Photograph of the fiberglass pipe for PA 2 showing the color variations change in 1998 for PA2.

The coloration of the fiberglass pipe was photographed for use in future assessments of the aging process of the fiberglass pipe under VLF operating conditions. The discoloration of the pipe was mapped for all the cabinets. Figure 2 shows the color variations obtained for PA 2 in 1998. In general, the outlet pipes have a darker amber color than the inlet side pipes, but there were significant variations in the color for both inlet and outlet due to the variations in batch production of the pipe. There appeared to be color discontinuities in some of the piping where a splice has been used to join two pieces of pipe (indicated by arrow).

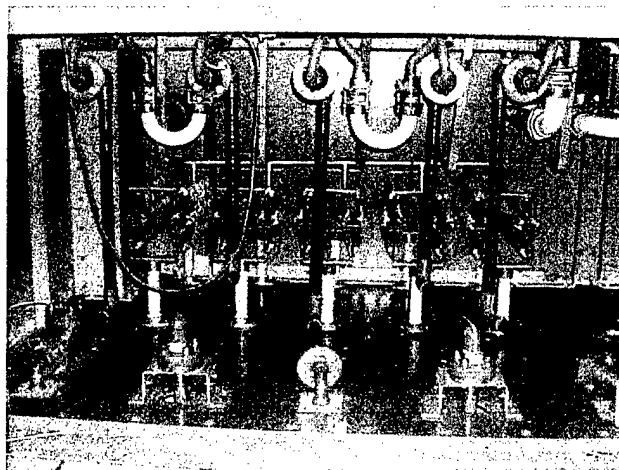
Figure 3. 2002 Photograph of the fiberglass pipe for PA 2 showing the color variations.

Figure 3 shows the same section of pipe (PA 2 left) photographed in April 2002. It is obvious that the Green Thread pipe has aged to a relatively uniform amber to dark amber color. There is no yellow green pipe coloration in the PA cabinets. The arrow in figure 3 denotes the location of the splice indicated in figure 2. The overall color of the

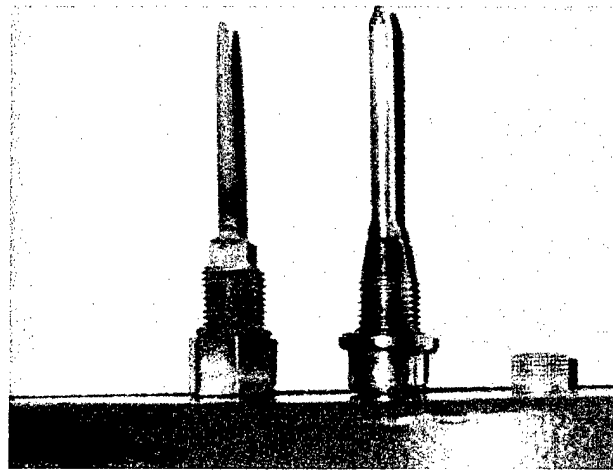
At that time, selected copper targets were removed from six of the piping segments to allow for the collection of water and also for the collection of swipe samples in the vicinity of the fiberglass pipe. This procedure was performed on pipe segments that were dark amber and those that were light green/amber in color so as to gain some variation, if it exists, in dissolved copper concentrations in the cooling water that is in intimate contact with the fiberglass pipe (keeping in mind that the water is mixed back in the PA tanks). Copper concentrations obtained from the swab samples ranged from 0.03 to 0.06 mg/l. In discussions with site personnel in May 2000, they stated that there was no increase in the erosion rate of the copper targets since the fiberglass pipe had been installed nor had targets been replaced since the installation of nitrogen generation system. As was the case with the Lualualei site, replacement targets were of a slightly different design so a comparison could not be made between the "in use" target and its replacement (see figure 4).

Figure 4. Targets from Jim Creek: on left side, old style target that had been in use for several years; new style target on right.

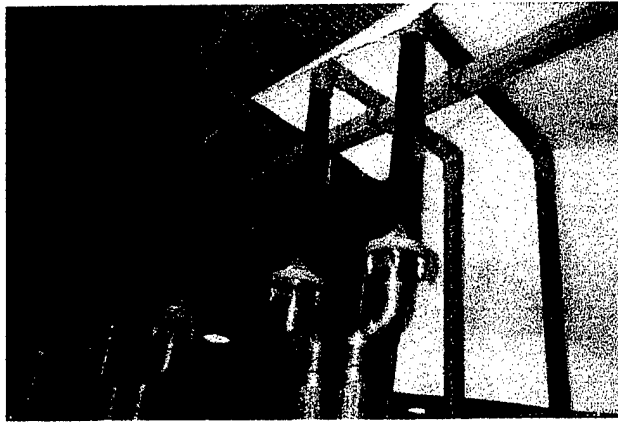
The fiberglass pipe (figure 5) was installed in February 1997 and had been in service for approximately 13 months (May 1998). The upper summer time operating temperature for the cooling water is approximately 110°F. The color variations in the fiberglass pipe at that time were less intense at Jim Creek than those at Lualualei, HI. Once again, the variations in color adhere to the rule that the warmer the pipe (i.e., higher temperature of the cooling water) the darker the color. However, similar to the Lualualei site, there are light green/amber fiberglass pipe on the hotter exiting water with multiple variations to the general color distribution. There are cases where there is a light green/amber section of pipe immediately attached to the exit flange, the next segment of pipe is dark amber and the remaining segment of pipe is light green/amber. The

Figure 5. 1998 photograph of fiberglass pipe discoloration for 13V1001 (starboard side).

explanation is probably in the quality control of the fiberglass pipe batches, pipe age and ambient temperature of the situation. As can be seen in figures 5 and 6, the color of the fiberglass pipe has darkened but retained the same color differentials. It may take a very long in service time (many years) before the Jim Creek site fiberglass pipe obtains a relatively even dark color like Lualualei.

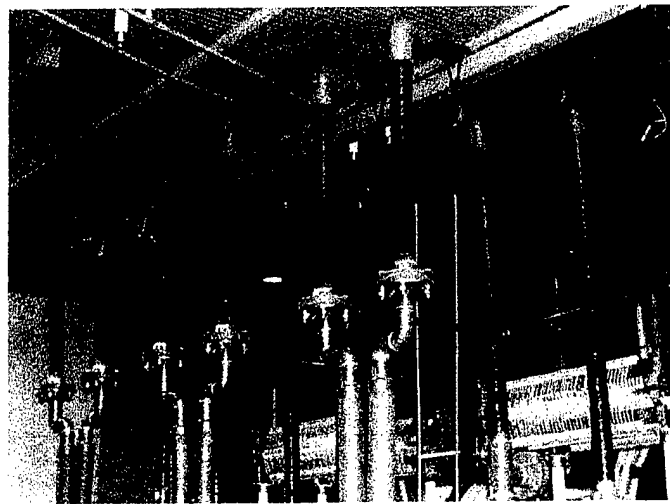
Figure 6. 2002 photograph of the fiberglass pipe discoloration for 13V1000 (starboard side).

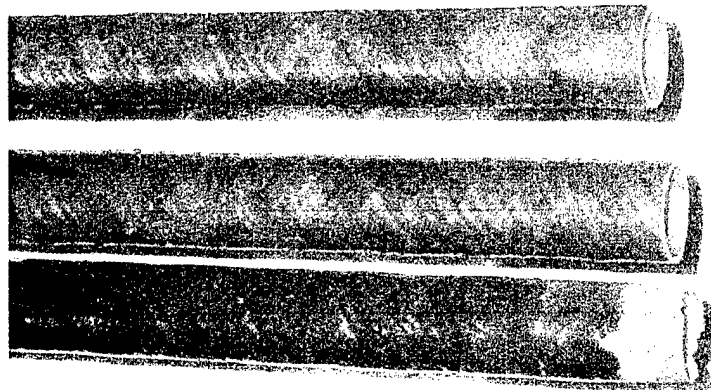
Figure 7 shows how different the color changes can be obtained for the Green Thread pipe over a period of time. Several pieces of Green Thread pipe were stored in

Figure 7. Green Thread pipe stored in warehouse at Lualualei site, March 2001.

the warehouse away from the transmission site at Lualualei. The temperature in the storage building at Lualualei was in the high 90s in March 2001. There is no air conditioning in that building but the room was filled with sunlight. We have an example of darker amber, medium amber and a medium yellow-green color. In this case, heat and UV light play a role in the color conversion. In contrast, several pieces of fiberglass pipe that were left at the Jim Creek site after installation over 4 years ago still have the light yellow/green and darker green color (Figure 1). There is no air conditioning for the Jim Creek storage site but the temperature in the storage area probably rarely exceeds 80° F. There is no incident sunlight in the Jim Creek storage room. The pipe is virtually “in the dark” unless someone enters the room and turns on the light or opens the outside storage doors. This pipe from Jim Creek is also an excellent example of the quality control for color. There is already a piece of pipe which exhibits a much darker quality (green) which will turn more quickly into a dark/amber color when subjected to increased temperatures.

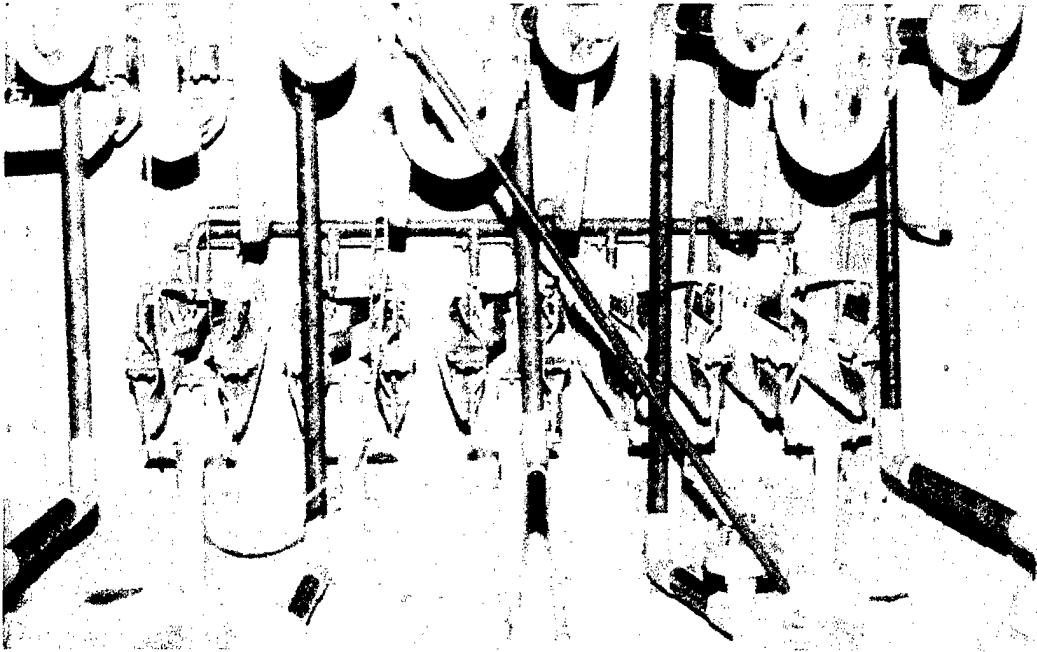
Figure 1. 1998 photograph of PA 1 (right side) fiberglass pipe showing color variations.

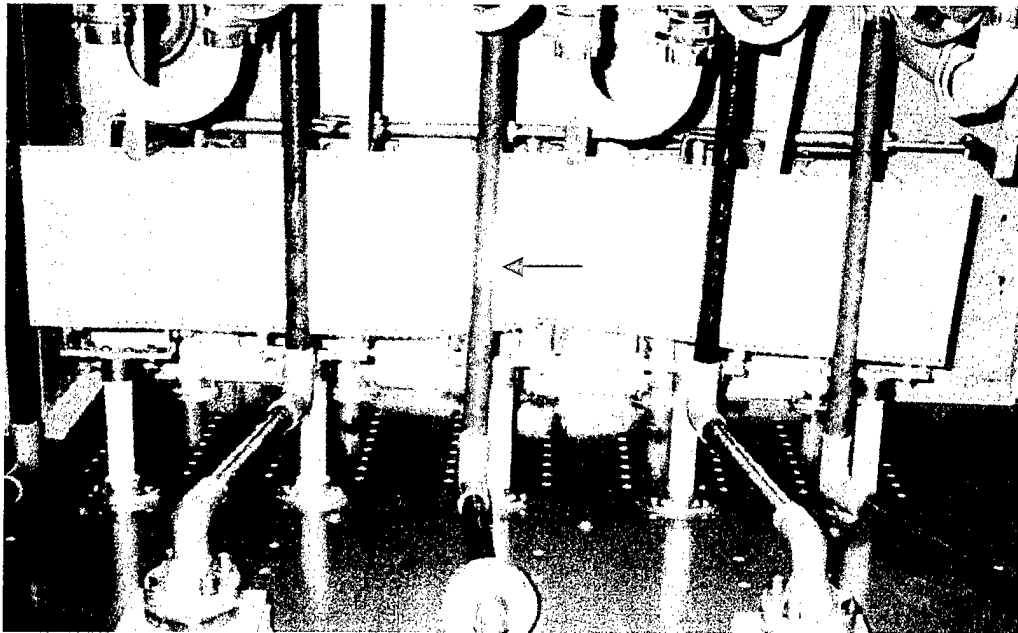
Figure 2. 1998 photograph of PA 2 (left side) fiberglass pipe showing color variations. Discontinuity of color (arrow) in center pipe is probably due to splice.

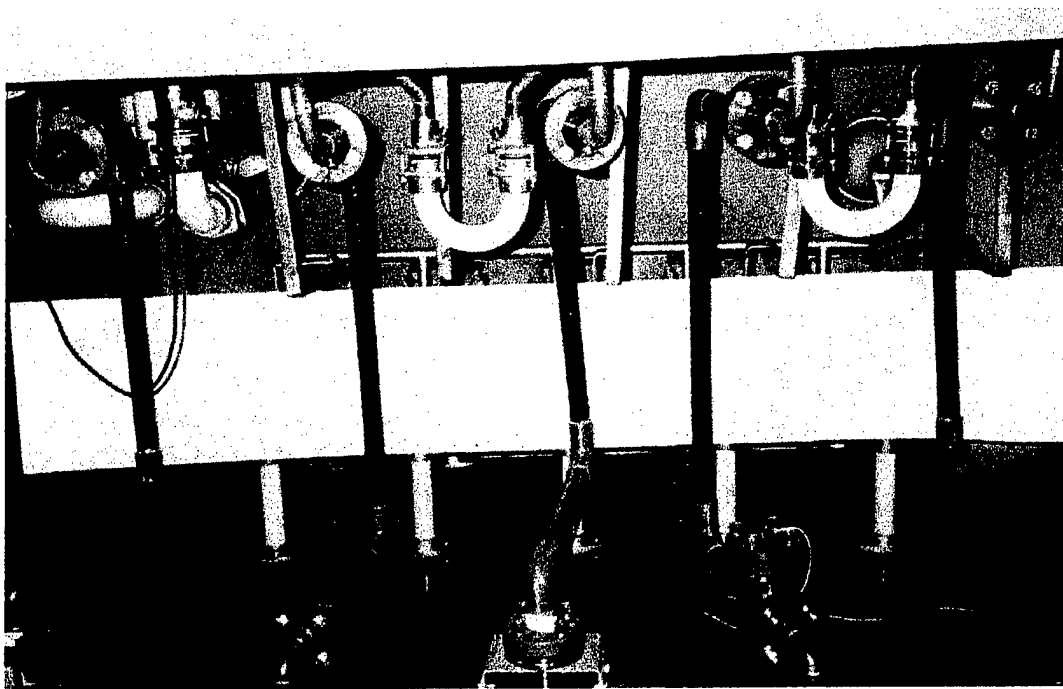
Figure 3. 2000 photograph of PA 1 (right side) fiberglass pipe showing that the color variations are almost nonexistent.

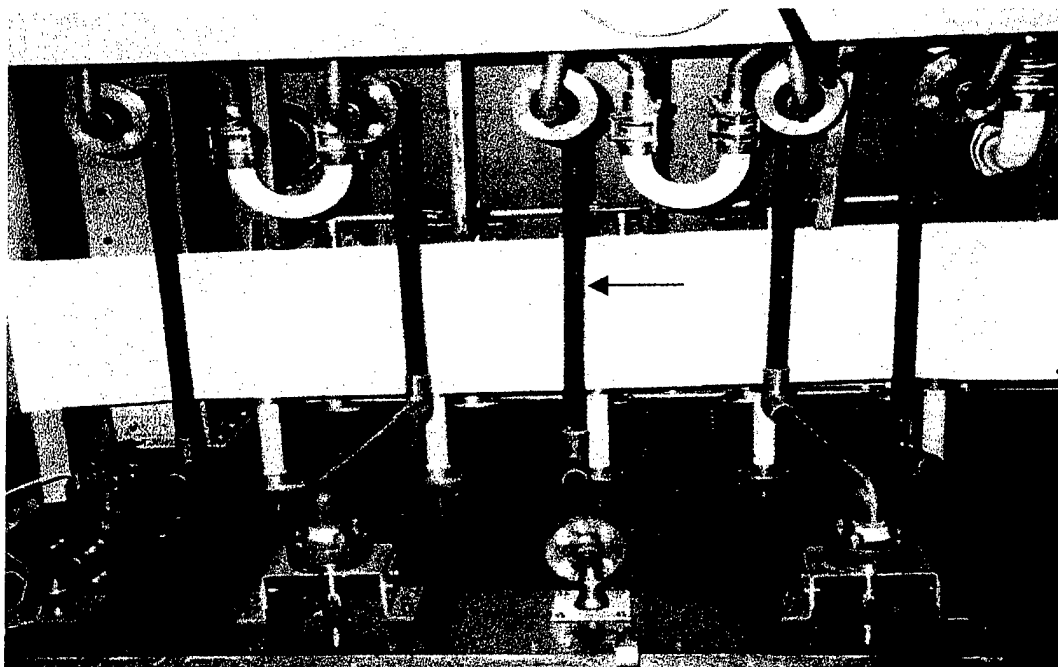
Figure 4. 2000 photograph of PA 2 (left side) fiberglass pipe showing color variations. Only slight indication of discontinuity (arrow) of color in center pipe shown in figure 2.

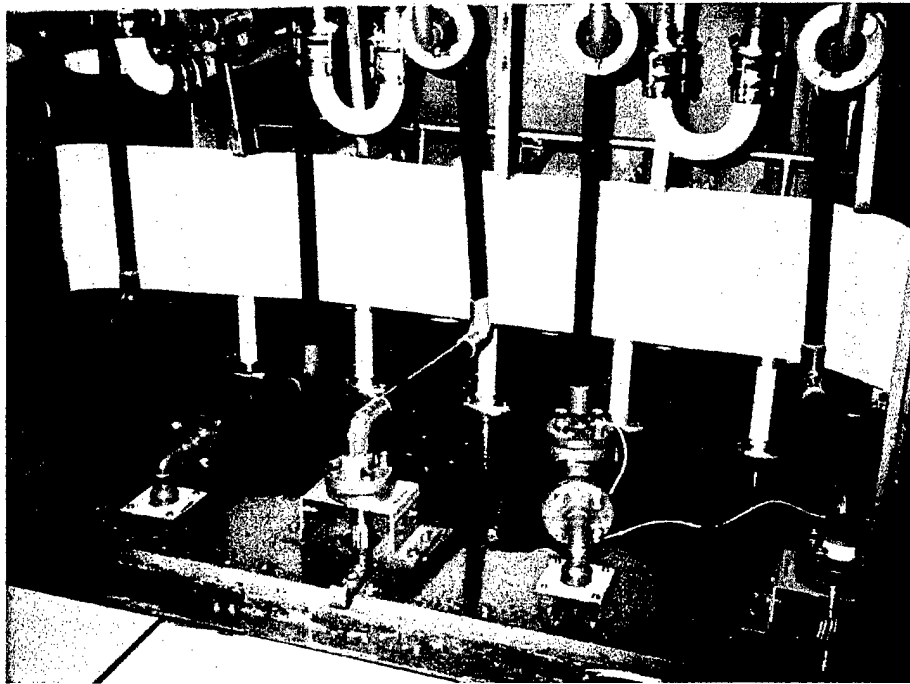
Figure 5. 2001 photograph of PA 1 (right side) fiberglass pipe showing that the color variations are almost nonexistent.

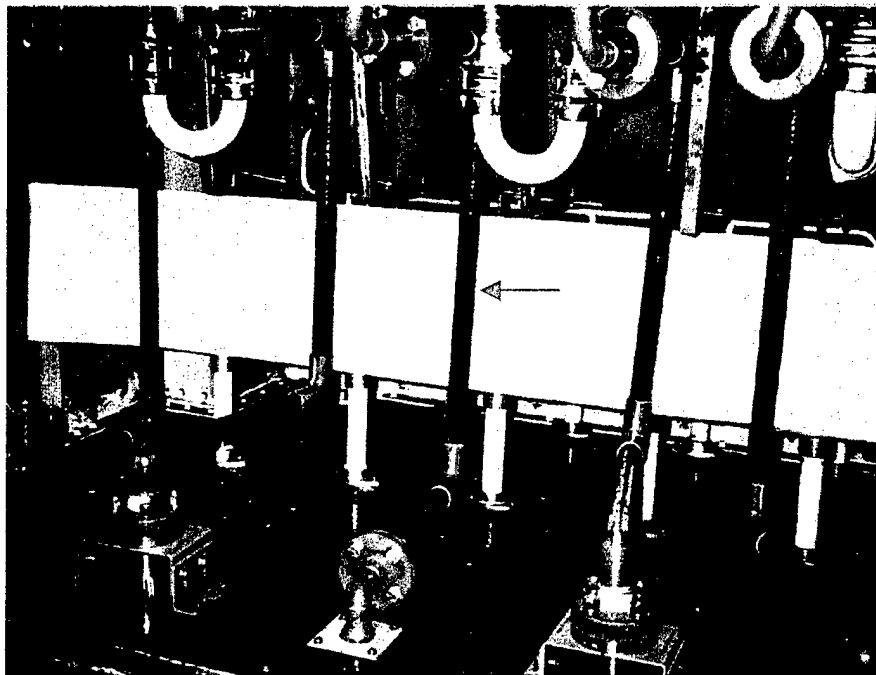
Figure 6. 2001 photograph of PA 2 (left side) fiberglass pipe showing no color variations. Arrow indicates where discontinuity occurred in Figures 2 and 4.

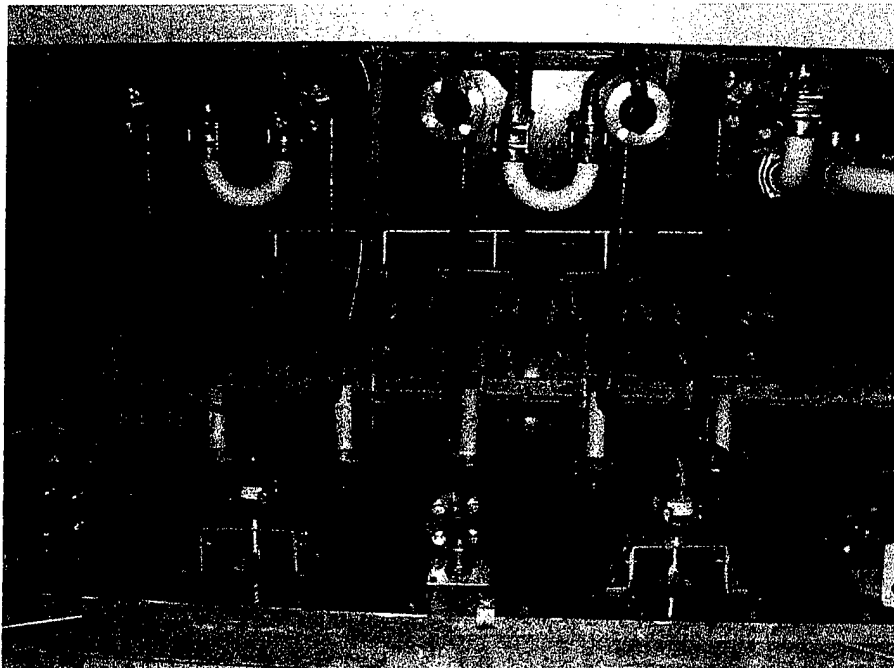
Figure 8. 2002 photograph of PA 2 (left side) fiberglass pipe showing no color variations.

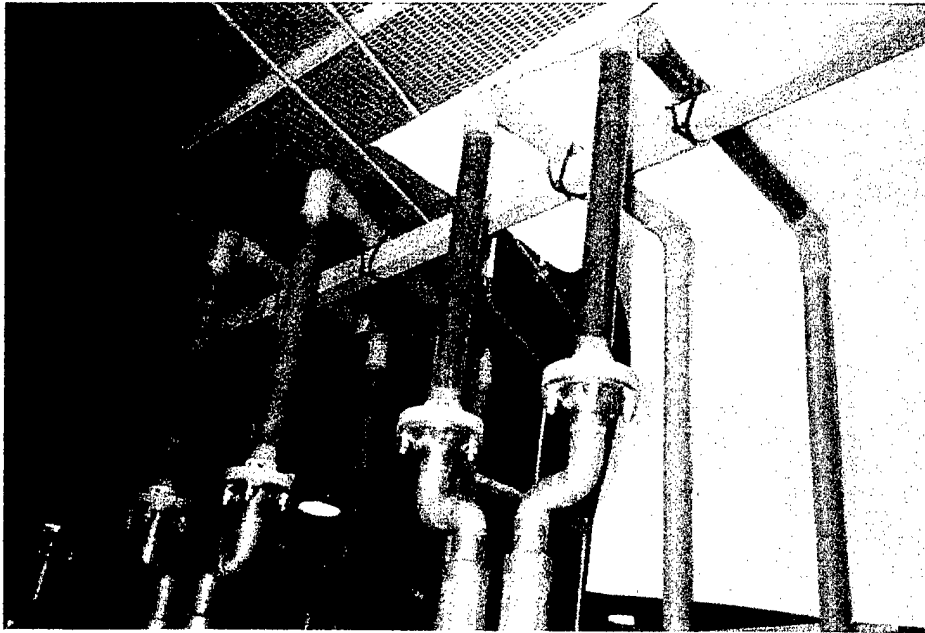
Figure 9. 1998 photograph of fiberglass pipe discoloration for 13V1001 (starboard side)

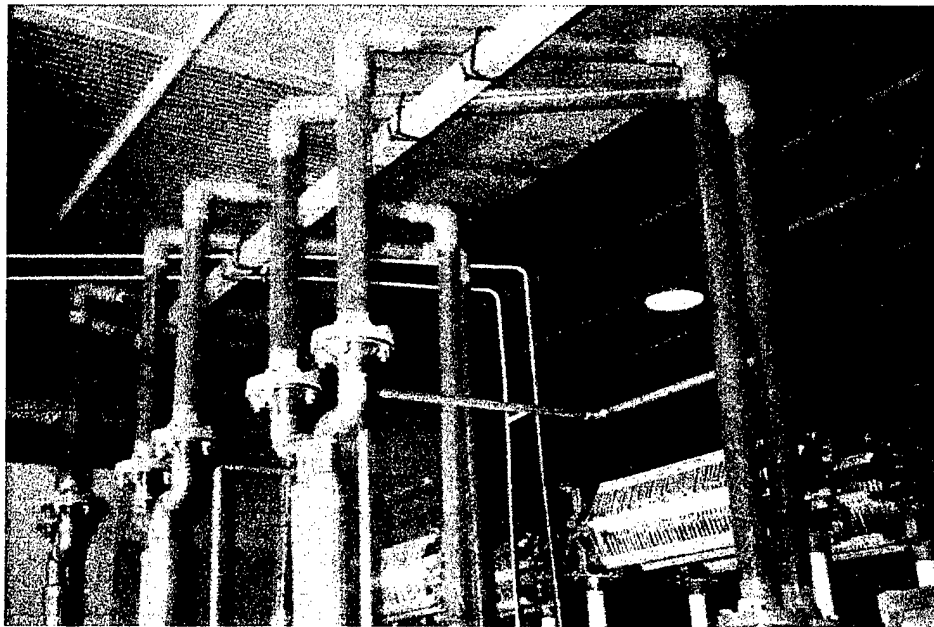
Figure 10. 1998 photograph of fiberglass pipe discoloration for port side PAs. Relatively even color distribution as compared to figure 7.

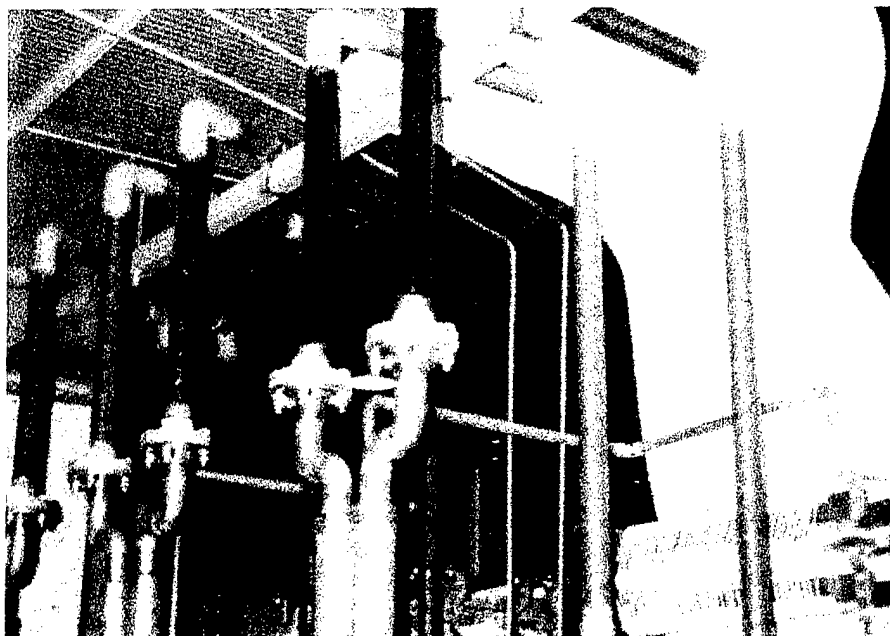
Figure 11. 2000 photograph of fiberglass pipe discoloration for 13V1001 (starboard side)

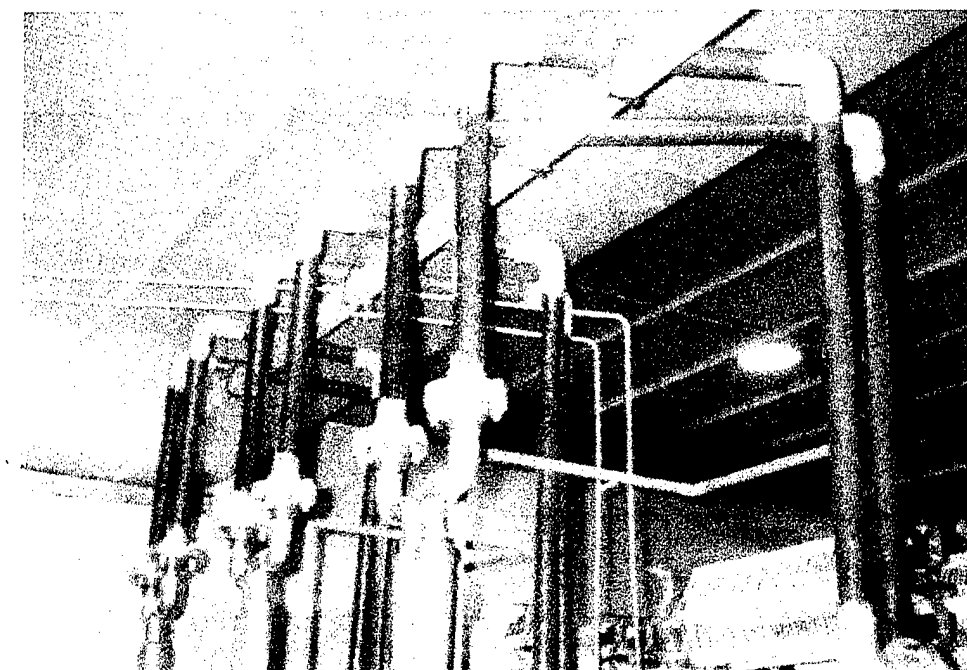
Figure 12. 2000 photograph of fiberglass pipe discoloration for port side PAs.

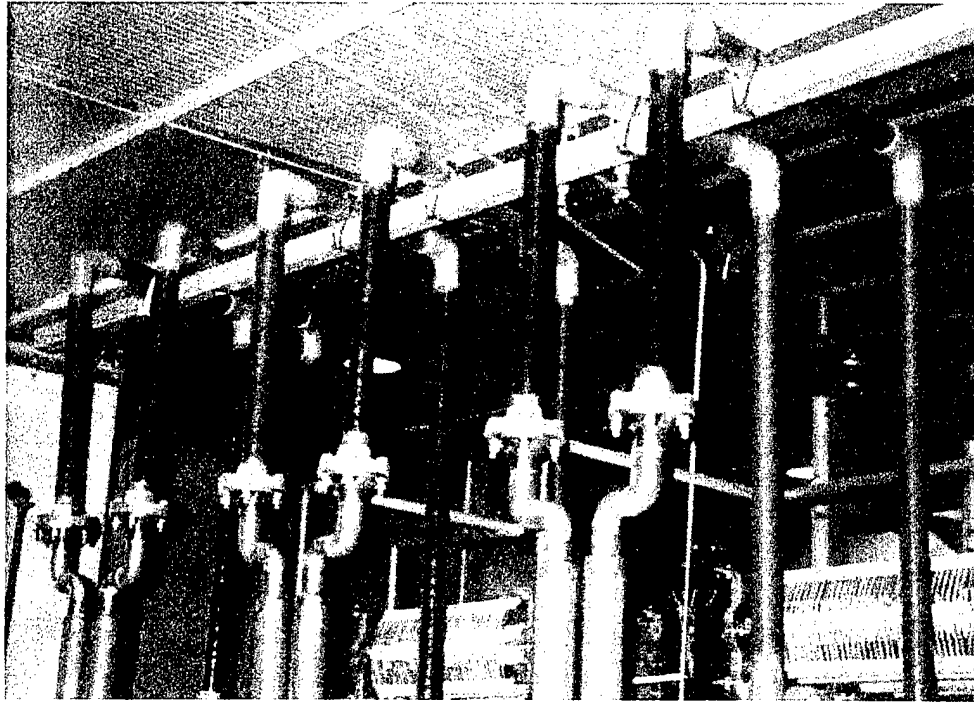
Figure 13. 2001 photograph of fiberglass pipe discoloration for 13V1001 (starboard side).

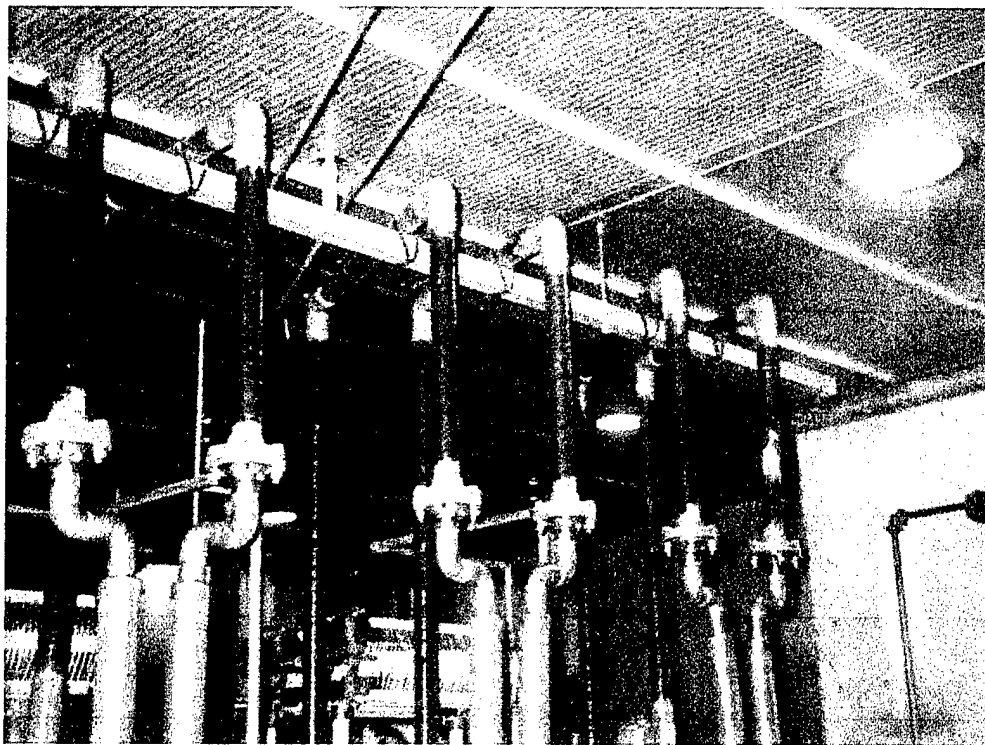
Figure 14. 2001 photograph of fiberglass pipe discoloration for portside PAs.

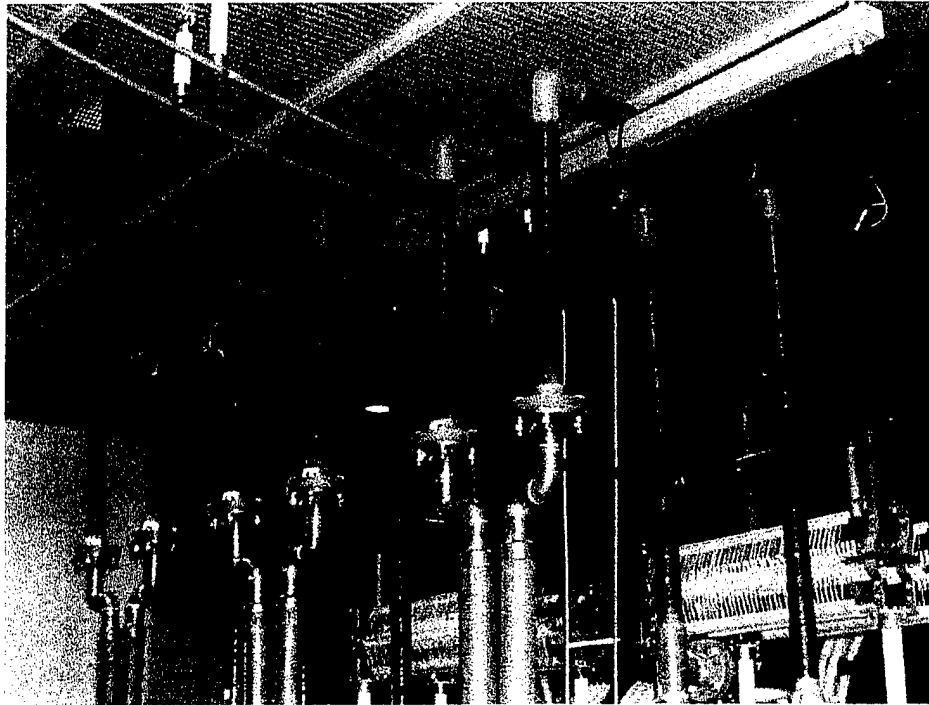
Figure 15. 2002 photograph of fiberglass pipe discoloration for 13V1001 (starboard side).

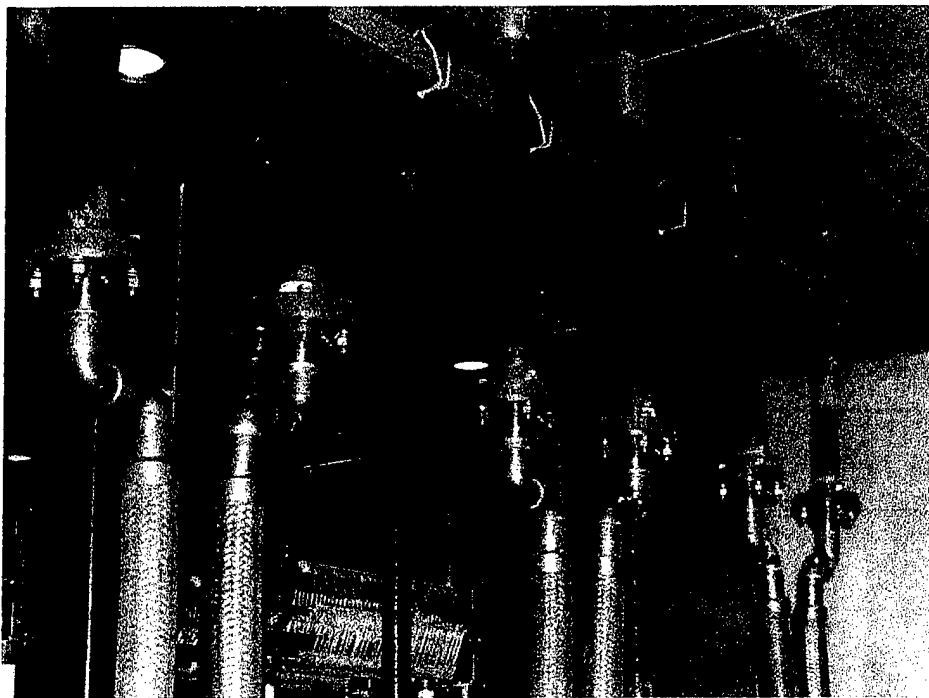
Figure 16. 2002 photograph of fiberglass pipe discoloration for portside PAs
